**BRE Properties, Inc.**  
**Screening Audit**

Date  
**November 26, 2007**

# **BRE PROPERTIES ENERGY EFFICIENCY OPPORTUNITIES**

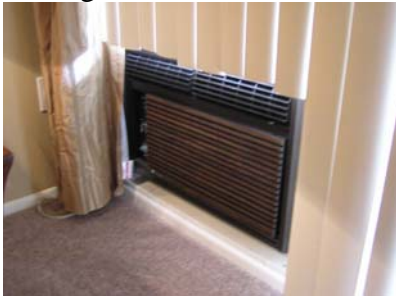
One of the five sites contained through the wall package terminals units. The package terminal units have filters that should be checked on a regular basis and replaced when needed. Utility programs provide incentives for energy efficient package terminal AC units and heat pumps.

Package terminal units

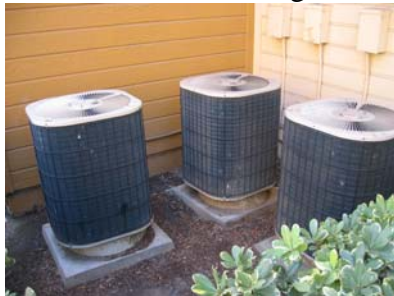
The condensing units for the apartments with central cooling are located outside. As the AC units need to be replaced, they should be replaced with high efficiency units with a SEER of 14 or greater. Units over 20 years old are reaching the end of their useful life and should be considered for replacement. Many condensing units are in locations surrounded by dirt and shrubbery. Regular cleaning of the condenser coils will make the units run more efficiently. Filters should be checked regularly and replaced when dirty.

Central AC condensing units

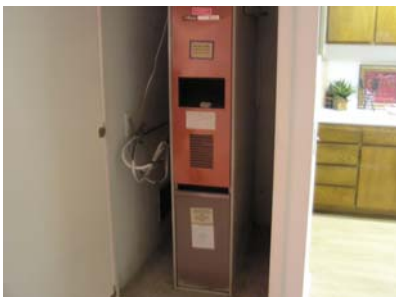
In apartments without heat pumps, heating is provided by either gas furnaces or central hot water boilers. Utility programs provide incentives for replacement of old furnaces with high efficiency gas furnaces. Filters should be checked regularly and replaced when dirty.

Gas forced air unit

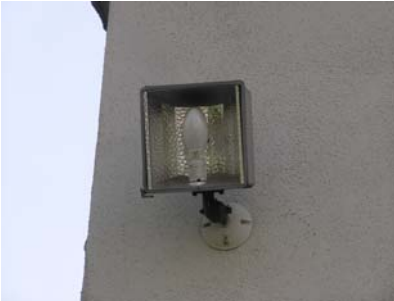
The common area exterior lighting is predominantly HID or fluorescent. The fluorescents are either straight tube or CFL. This lighting includes fixtures on building walls, stairs, front door porch lights, carports and general walkway lighting.

Building HID

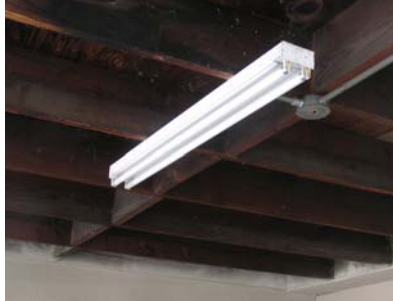
Carport fluorescents

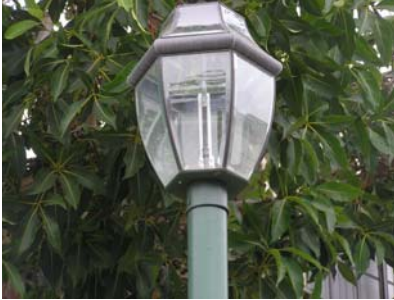
Walkway CFLs

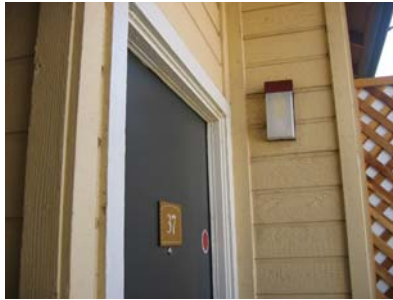
Building CFLs

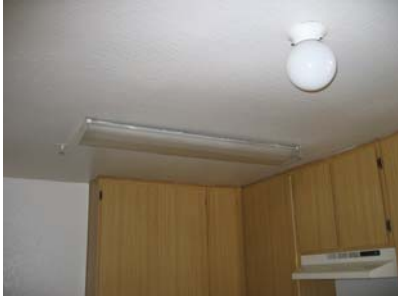
In the interior, some of the apartments have incandescent lights in bathrooms, recessed hallway fixtures and ceiling fans. Incandescent lamps are being used on all back porch fixtures in one 240 unit complex. Older 4' T12 fluorescent lamps are being used in laundry rooms and kitchens. They can be replaced with energy efficient T8 lamps and electronic ballasts. Ceiling fans can be replaced with Energy Star rated fans. Utilities may offer programs to retrofit apartment complex lighting at no cost to the customer.

Fluorescent & incandescent bulbs

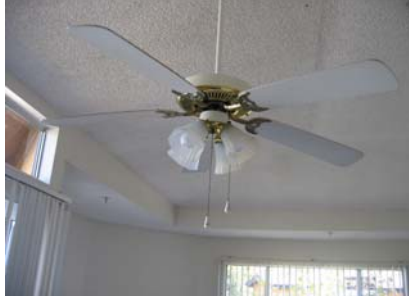
Fans containing incandescent bulbs

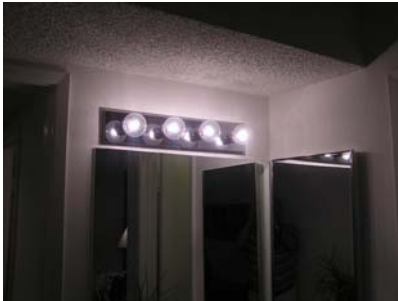
Bathroom with incandescents

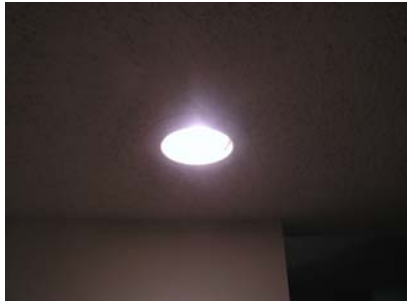
Recessed cans

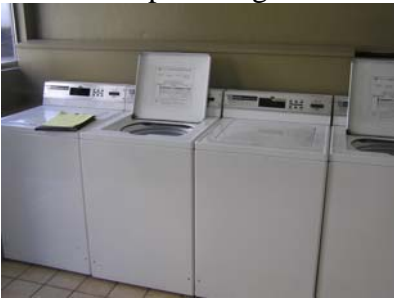
Most of the complexes have central laundry facilities, however, one complex has washers and dryers in each apartment and another is converting at this time. Washers and dryers in the central laundries don't appear to be Energy Star rated. Upon replacement they should be specified Energy Star.

Standard top loading washers

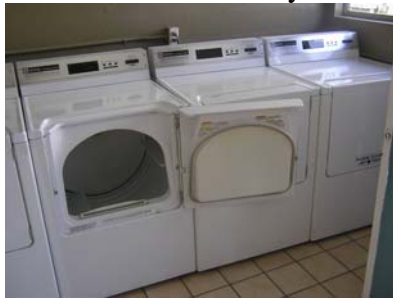
Standard front load dryers

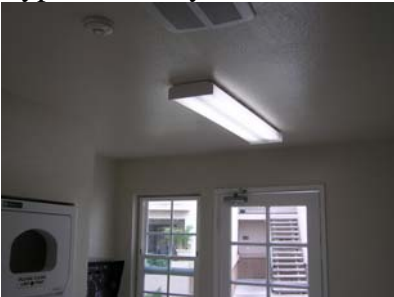
The central laundries could be considered for solar water heaters. One complex had solar at one time and is still plumbed for solar, however, the storage tanks are disabled and collectors have been removed. Lighting in the laundry facilities is T12 fluorescent lighting and could be retrofitted to T8.

Typical laundry fluorescent fixture

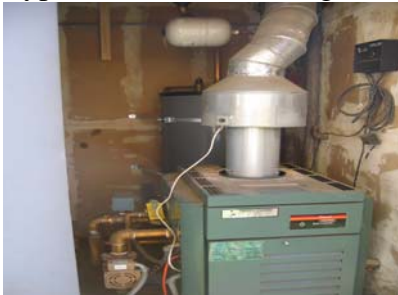
DHW was generally provided to the complexes through central systems located at each building. Temperatures were found ranging from 140° to 167°. Boilers have the potential for automated controls to match the heating load with use patterns and upon replacement, condensing boilers should be considered. One of the five complexes was found to have individual water heaters.

Typical boiler with storage tank

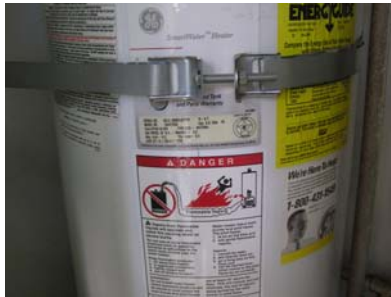
Individual water heater

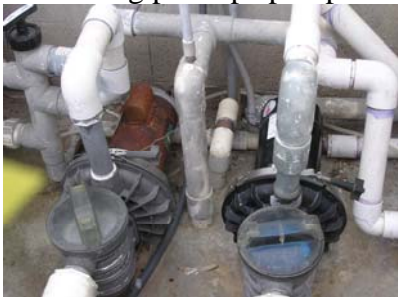
All complexes had heated swimming pools and spas but none had pool covers. Covers can help to reduce heat loss and maintenance costs. Rebates for high efficiency pumps or variable speed or two speed pumps are available through the local utility.

Time clocks control the operation of the filter pumps. Some were found operating 24 hours. City or county health departments specify the number of hours required for filtering for each particular pool based on the time required for the pump to turn over the water in a specified time, usually 6 hours, or remain filtering during posted pool hours. Pool filtering requirements should be investigated which could potentially result in reduced operating hours when the pool is closed.

Swimming pool/spa pumps

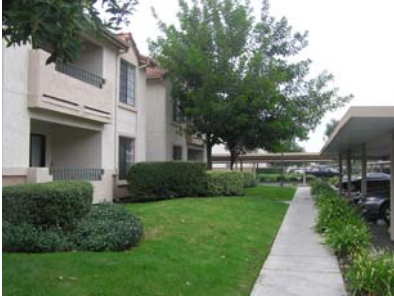
None of the complexes were found to be landscaped with drought resistant landscaping. All of the complexes were landscaped with typical Southern California foliage.

Typical walkway landscaping

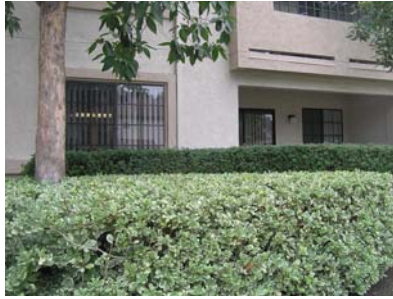
Typical building landscaping

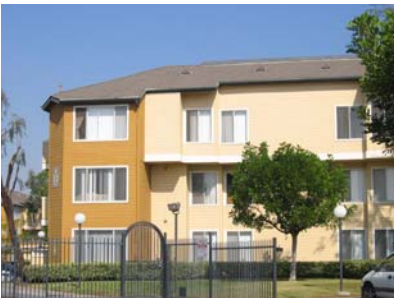
Villa Santana

All complexes were observed to have clear glass with aluminum frames. Window areas were estimated at 15% to 30% of wall surface. The windows generally are not shaded, however, some shading is provided by decks or porches and some trees. Roofing material is medium in color.
