BRE Properties, Inc.
Screening Audit

Date
November 26, 2007

BRE PROPERTIES ENERGY EFFICIENCY OPPORTUNITIES

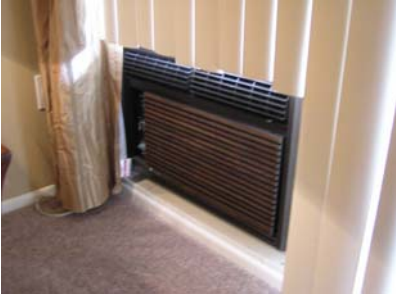
One of the five sites contained through the wall package terminals units. The package terminal units have filters that should be checked on a regular basis and replaced when needed. Utility programs provide incentives for energy efficient package terminal AC units and heat pumps.

Package terminal units

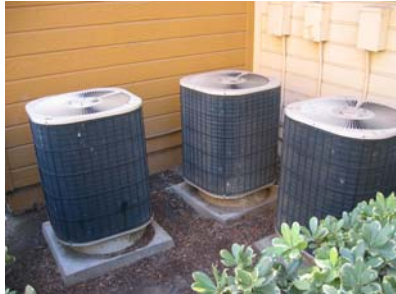
The condensing units for the apartments with central cooling are located outside. As the AC units need to be replaced, they should be replaced with high efficiency units with a SEER of 14 or greater. Units over 20 years old are reaching the end of their useful life and should be considered for replacement. Many condensing units are in locations surrounded by dirt and shrubbery. Regular cleaning of the condenser coils will make the units run more efficiently. Filters should be checked regularly and replaced when dirty.

Central AC condensing units

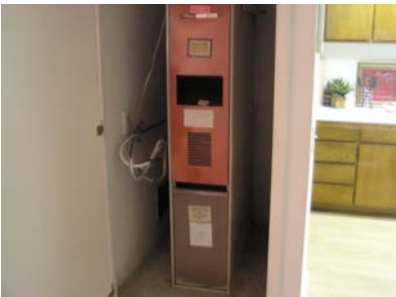
In apartments without heat pumps, heating is provided by either gas furnaces or central hot water boilers. Utility programs provide incentives for replacement of old furnaces with high efficiency gas furnaces. Filters should be checked regularly and replaced when dirty.

Gas forced air unit

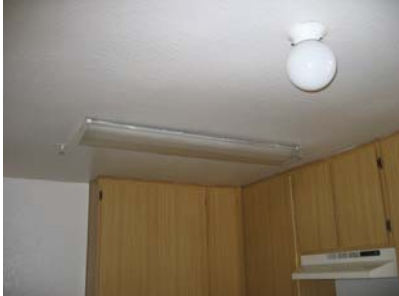
In the interior, some of the apartments have incandescent lights in bathrooms, recessed hallway fixtures and ceiling fans. Incandescent lamps are being used on all back porch fixtures in one 240 unit complex. Older 4' T12 fluorescent lamps are being used in laundry rooms and kitchens. They can be replaced with energy efficient T8 lamps and electronic ballasts. Ceiling fans can be replaced with Energy Star rated fans. Utilities may offer programs to retrofit apartment complex lighting at no cost to the customer.

Fluorescent & incandescent bulbs

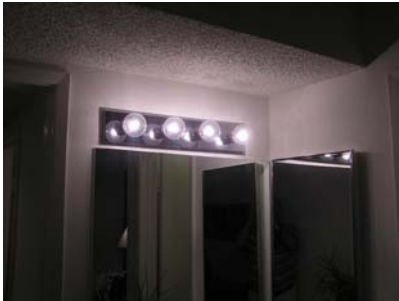
Bathroom with incandescents

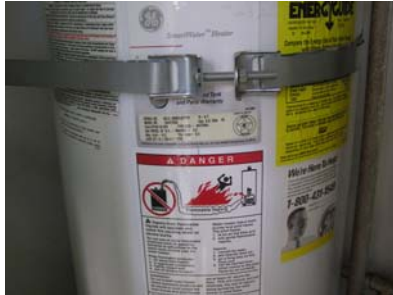
Individual water heater

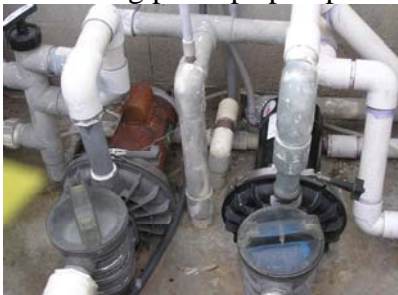
Time clocks control the operation of the filter pumps. Some were found operating 24 hours. City or county health departments specify the number of hours required for filtering for each particular pool based on the time required for the pump to turn over the water in a specified time, usually 6 hours, or remain filtering during posted pool hours. Pool filtering requirements should be investigated which could potentially result in reduced operating hours when the pool is closed.

Swimming pool/spa pumps

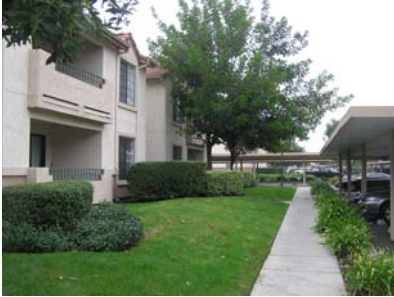
None of the complexes were found to be landscaped with drought resistant landscaping. All of the complexes were landscaped with typical Southern California foliage.

Typical walkway landscaping

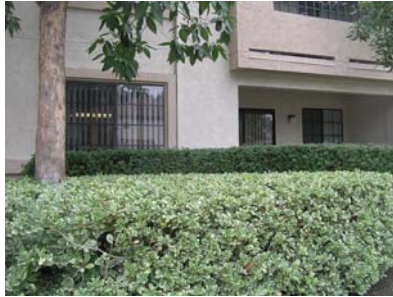
Typical building landscaping

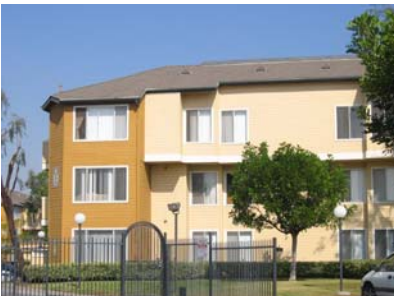
Villa Santana

All complexes were observed to have clear glass with aluminum frames. Window areas were estimated at 15% to 30% of wall surface. The windows generally are not shaded, however, some shading is provided by decks or porches and some trees. Roofing material is medium in color.
